APPLICATION CASE STUDY:

Project Description: Apply Product to Shower Walls & Floors in Gym Locker Room

Customer: LAC (Louisville Athletic Club)

Date: September, 2016

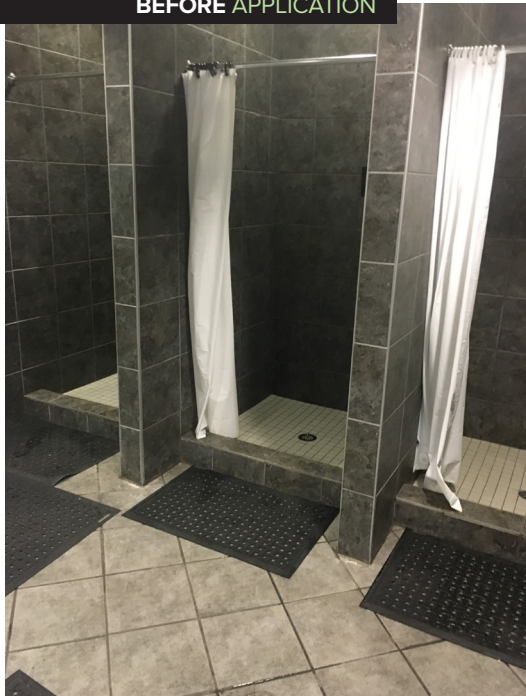
BEFORE APPLICATION

Project Overview: The floors and shower walls were dingy and showed water spots. The grout was stained on the floors and in the shower stalls. The Customer wanted to restore the floors and showers to like-new condition for their members. The customer desired a gloss coating to improve appearance.

Features & Benefits: The tile floors and shower walls were stripped and coated with X-PROTECT. The grout was cleaned and re-colored with new grout colorant. X-PROTECT was applied to the floors and shower walls to provide the gloss appearance desired by the Customer.
